ADVANCED METALLIC AIR VEHICLE STRUCTURE PROGRAM Return to Grammer when emplele.

SIXTH INTERIM REPORT

GENERAL DYNAMICS FORT WORTH DIVISION

TECHNICAL REPORT AFFDL-TR-76-74

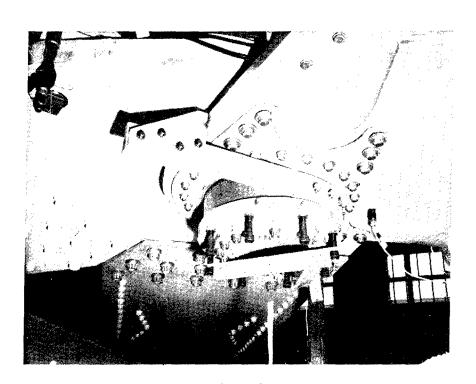
FIGURE 2.1.1-1

RETENTION OF UPPER BUSHING TO PIVOT PIN

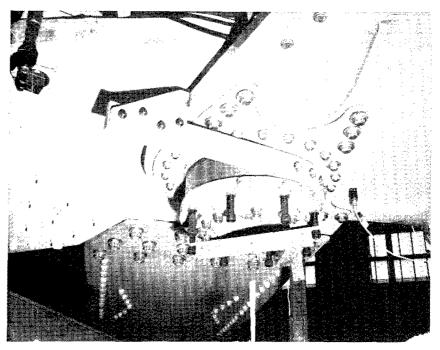
FIGURE 2.2.1-2
RETENTION OF UPPER BUSHING TO PIVOT PIN

During the inspection following flight 160, the pivot pins, bushings, and spacers at the juncture between the WCTS lugs and the dummy wing were found to have rotated considerably from their initial positions. (See Section 2.2.1) Several gages on the lugs showed significant changes from the early flights to flight 160. (Ref. Figures 2.1.2-3 and 2.1.2-4 and Tables 2.1.2-XII and 2.1.2-XIII.) Since one of the effects of the rotated bushings was to bend the lugs, it was concluded that the stress changes were probably due to geometry changes resulting from lug distortion. Unfortunately, continuous zero shift data was not obtained so preload stresses resulting from lug bending caused by bushing rotation were not available.

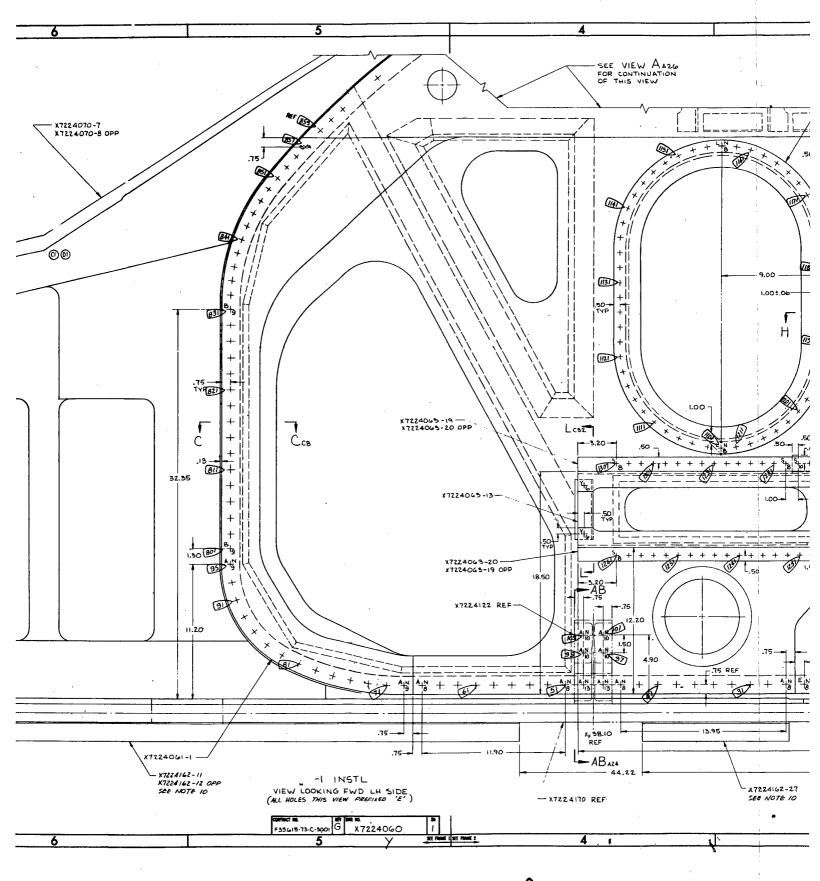
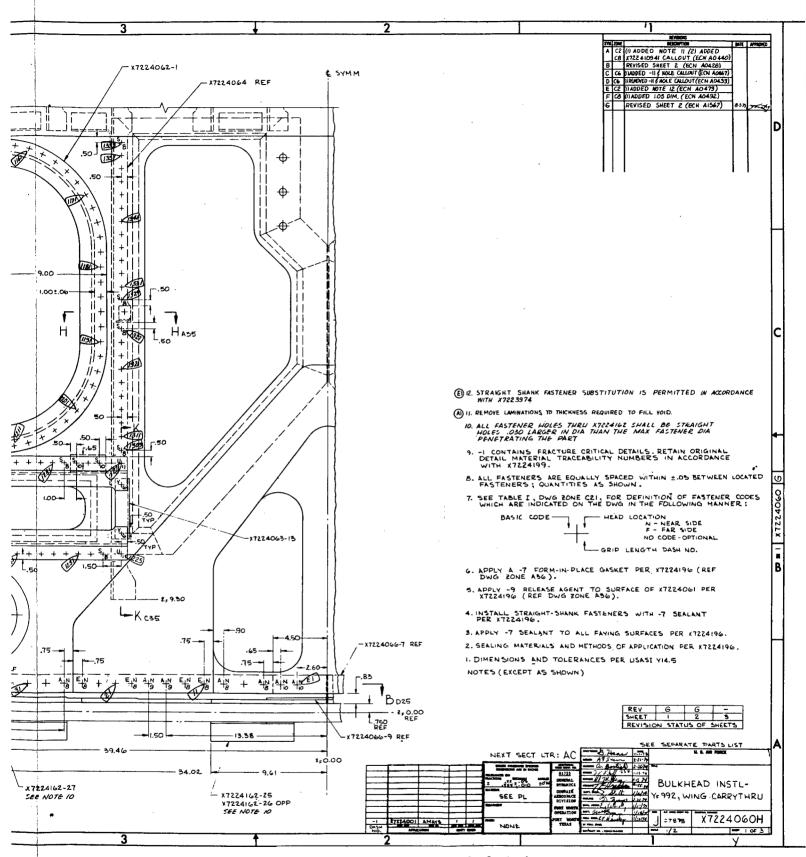
FIGURE 2.2.1-4, SHEET 1 OF 2 FASTENER HOLE IDENTIFICATION - $\rm Y_F$ 992 BULKHEAD

When the first 160 flights of the testing were completed, the scheduled Category II visual inspection was accomplished. Numerous fasteners were found to be loose in the Y_F 992 bulkhead access panels and in the simulated fuselage structure, especially from Y_F 992 to Y_F 1050. These fasteners were all retorqued.

Short threaded fasteners, attaching the access covers of the Y_F 992 bulkhead, were replaced with longer threaded bolts (NAS 674) to insure thread engagement with the locking feature of the nutplates.
